Brief Building Report Kollektivhuset

Site Location	Hans Knudsens Plads, Copenhagen, Denmark		
Type of Project	Facade renovation of multistorey housing block for disabled tenants		
Building size	224 flats		
Building Owner	Vanføres Boligselskab Københavns Kommune (Afdeling 1), foundation for disabled people in Denmark		
Short Description	Kollektivhuset is a building for disabled people located close to one of the most trafficated roads to the center of Copenhagen		
Author	Henrik Sørensen	Architect	DOMUS Arkitekter
Company	Esbensen Consulting Engineers Ltd.	Builder	Boligselskabet DVB
Address	Carl Jacobsensvej 25 D DK 2500 Valby Denmark	Designer	
Telephone	+45 33 26 73 00	BiPV system prov.	GAIA Solar
Email	h.soerensen@esbensen.dk

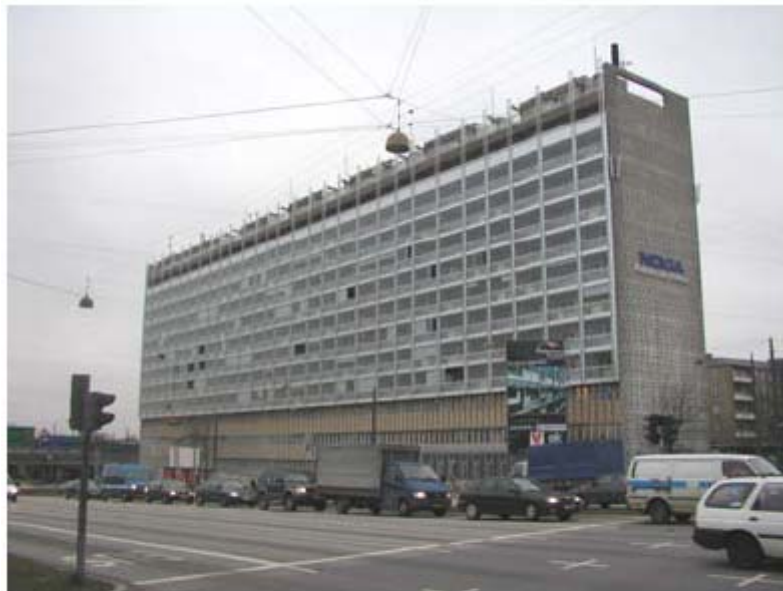
*Kollektivhuset, Hans Knudsens Plads
Copenhagen, Denmark. Photo: NCC.*

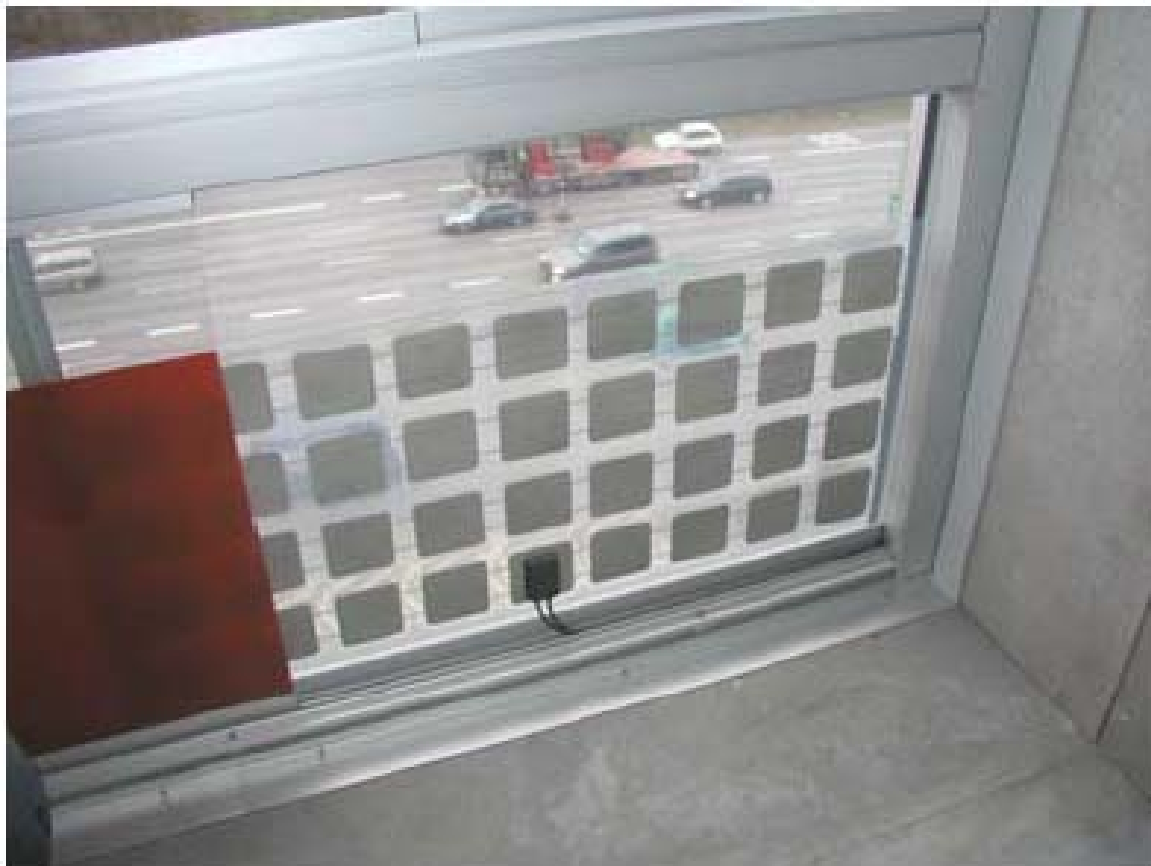
There are 224 PV-modules placed vertically on the facade of the balconies of the building. The modules are connected to four inverters which delivers the power to the grid. Solar cells are laminated to a sheet of toughened glass with EVA and transparent Tedlar.

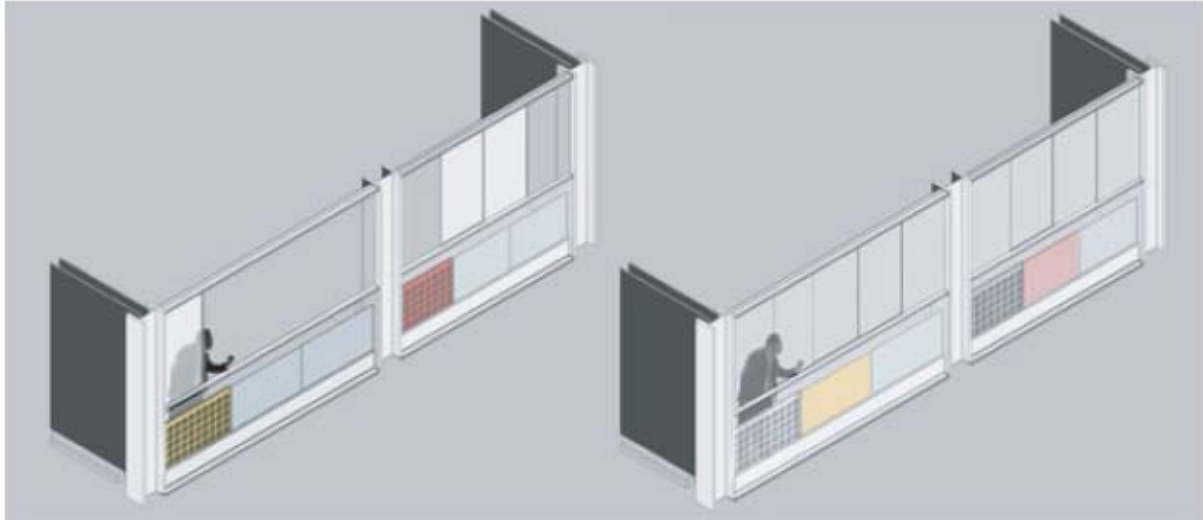
The front glass of the parapet is a normal glazed balcony glazing, ensuring water tightness and sound protection from the main road in front of the building. Behind this glazing the PV-modules are placed. The space between the front glass and the PV-module is ventilated to the exterior during Summer and to the interior during Winter.

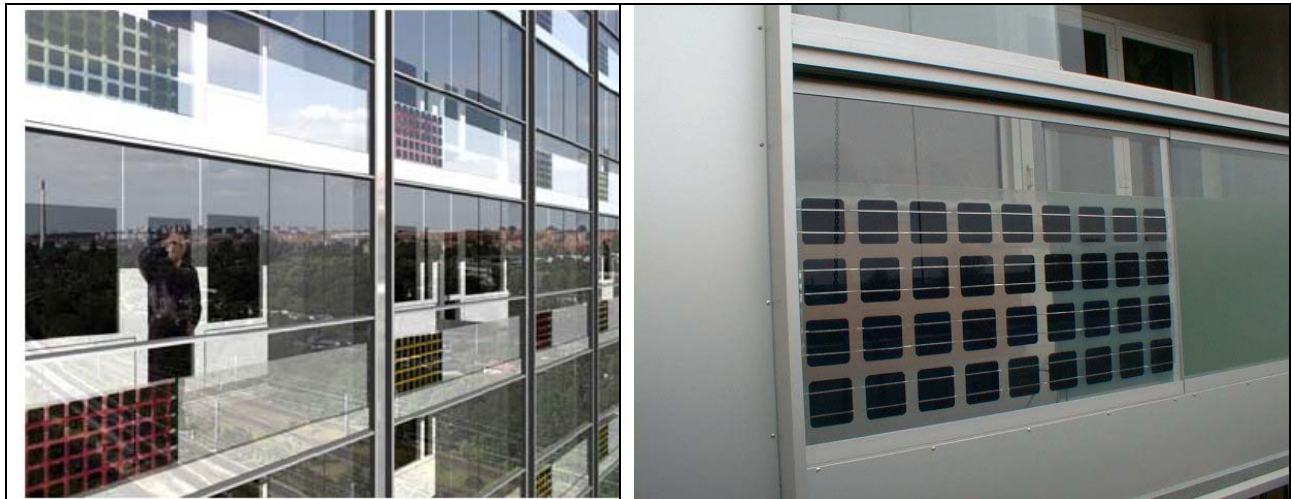
The PV-modules are visible from the outside of the building and with the combination of coloured glass sheets behind the modules, which are moveable, and living facade with small variations in the appearance is obtained.

On the pictures below both the anticipated visual appearance and the realised appearance of the building is shown.
